## Assessing regressive erosion effects: Unveiling riverside land use land cover changes post hydroelectric project construction

Assess the effects of regressive erosion along the Coca River through changes in land use and land cover (LULC) to identify the impact of CCSHP operations on migration, deposition, and river channel erosion during 2017–2021

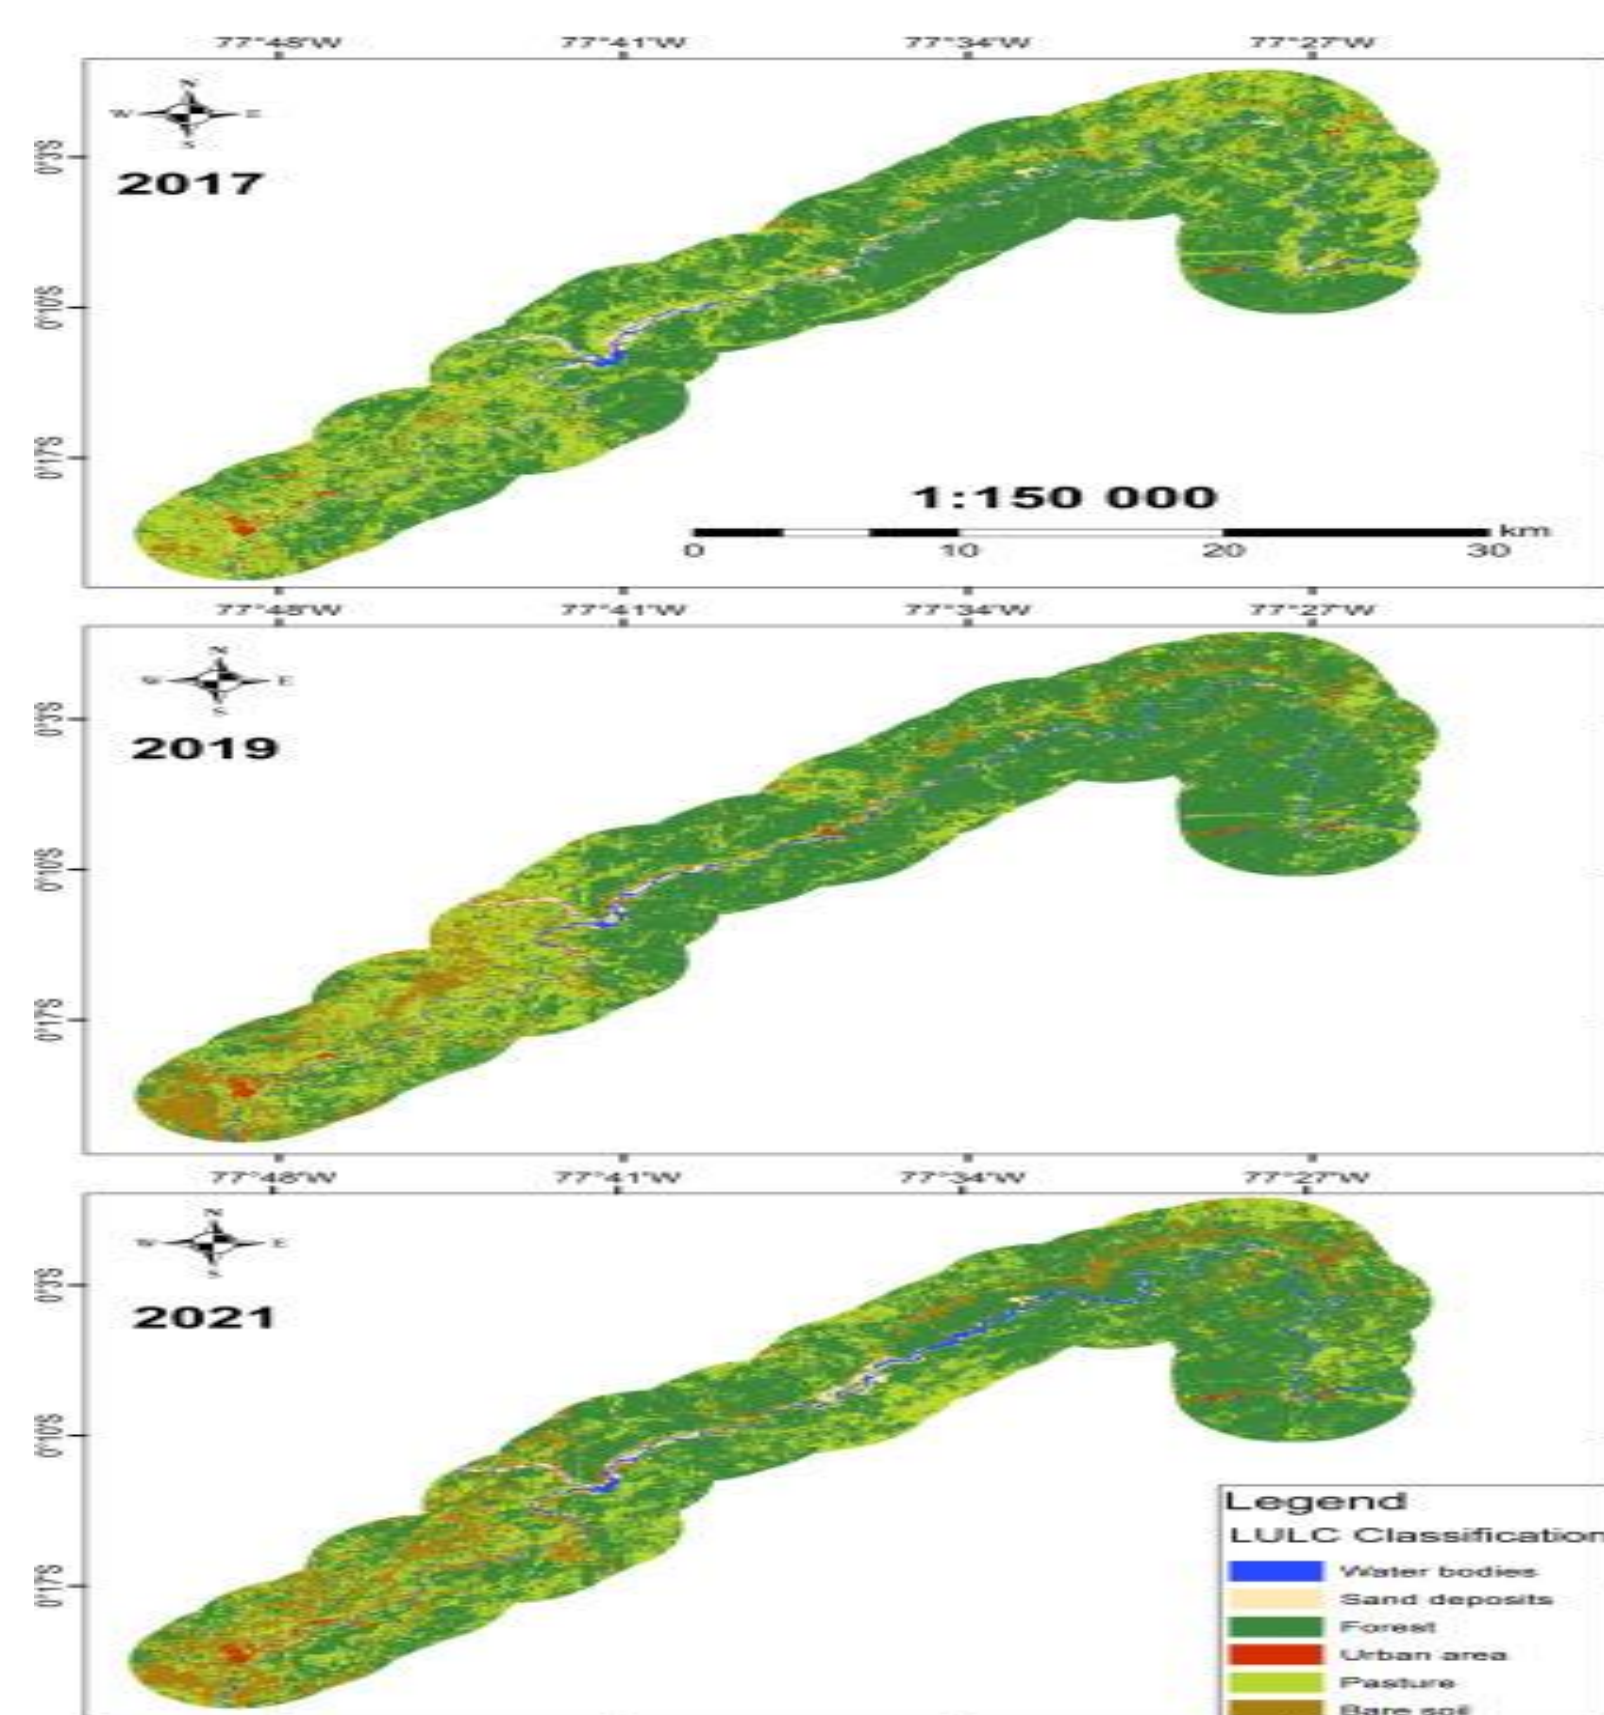
Fig. 4. LULC classification map within the AOI

LULC 2017		LULC 2019		LULC 2021	
Classes	ha	km <sup>2</sup>	ha	km <sup>2</sup>	ha	km <sup>2</sup>
Water bodies	763.73	7.64	1023.39	10.23	1292.78	12.93
Forest	37874.06	378.74	38553.27	385.53	35887.67	358.88
Pasture	21351.95	213.52	15935.49	159.35	16606.27	166.06
Bare soil	2069.98	20.70	7267.22	72.67	8574.66	85.75
Sand deposits	1231.54	12.32	528.29	5.28	916.45	9.16
Urban area	269.33	2.69	252.13	2.52	280.21	2.80
